**REPORT ON  
LAND USE/ VEGETATION COVER MAPPING OF BANDER  
COALFIELD OF WCL, BASED ON REMOTE SENSING  
TECHNIQUE USING SATELLITE DATA OF 2012**

**Western Coalfields Limited (WCL)**  
Nagpur, Maharashtra

**March 2013**

**Central Mine Planning & Design Institute Ltd.**  
Gondwana Place, Kanke Road  
Ranchi 834 008, India

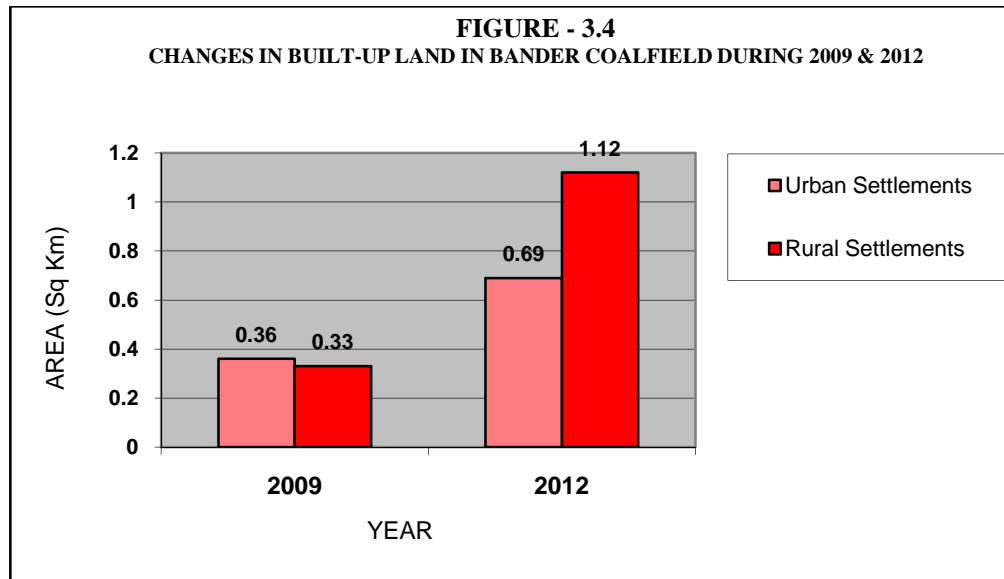
The variation in the Built-up Land/Settlements which took place during year 2009 and 2012 within the coalfield area are shown in bar diagram in Figure – 3.4

It is observed that the settlements within the coalfield have grown by 1.02 sq km, which is about 0.31% of the coalfield area. It is observed that the rural settlements have grown marginally by 0.79 sq km which is 0.22% of the coalfield area. The Urban settlement within the coalfield area has grown by about 0.33 sq km, i.e. 0.09%. This increase is due to the increasing trend of urbanisation.

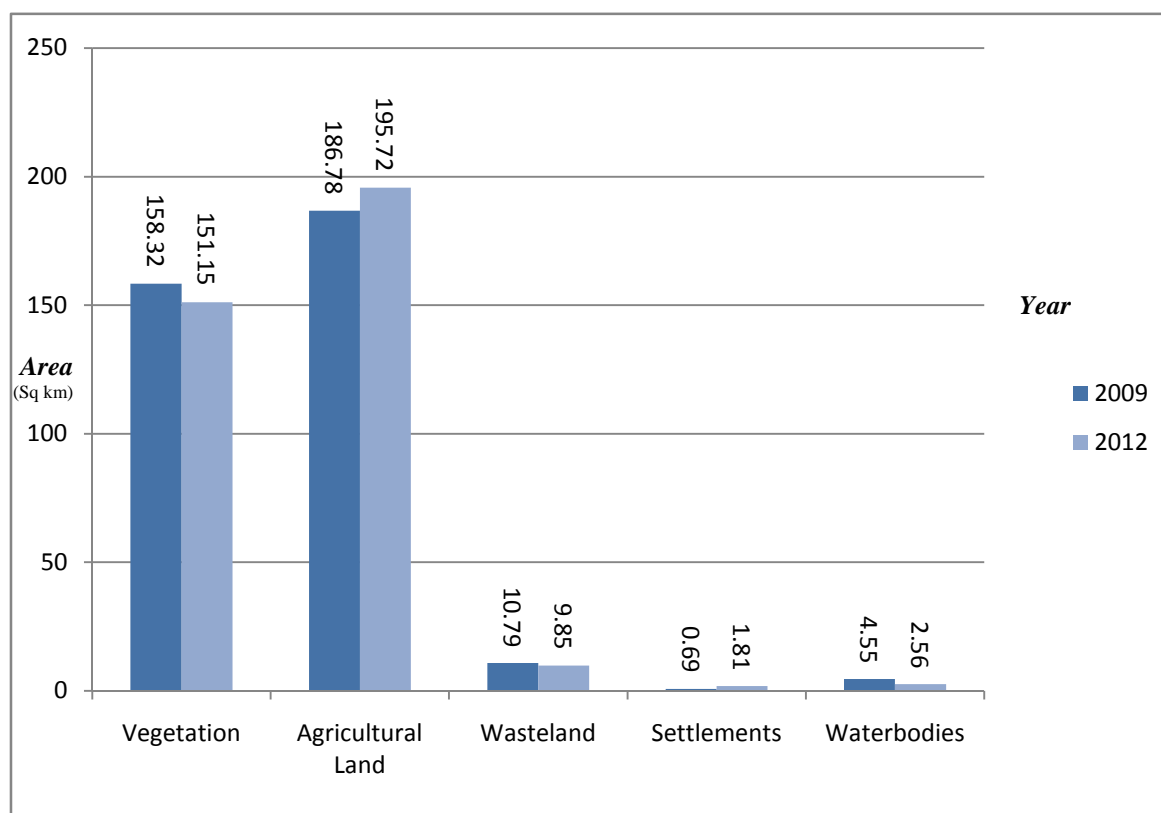
***Fig 3.6 Overall Changes in Land Use/Cover Classes in Bander Coalfield in the Year 2009 & 2012***

The overall variation in various Land Use /Cover classes in Bander Coalfield during the year 2009 and 2012 is shown in the Bar Chart below:

It can be seen from the chart above that there is a decrease in vegetation cover in the coal-field area mainly because of deforestation and scrub areas becoming suitable for the purpose of agriculture. Agricultural land has increased which may be due enhanced human activities near the forest areas and other related activities. Wasteland has also reduced due to increase in human activities. Settlements have also increased, which is due to increase in population and other related human activities.
